HONDA S-MX CAM COVER / CAM SEAL LEAK

So if you have an S-MX there is a good chance your cam end seal and/or cam cover gasket is leaking.

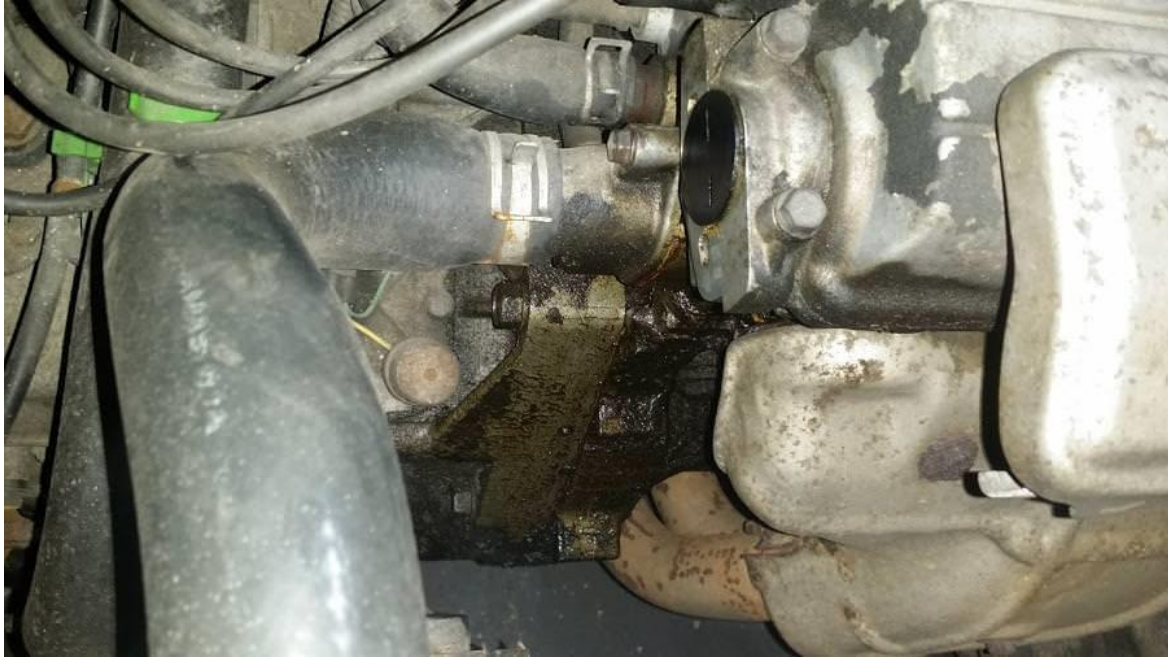
It will look something like this on the front of your engine

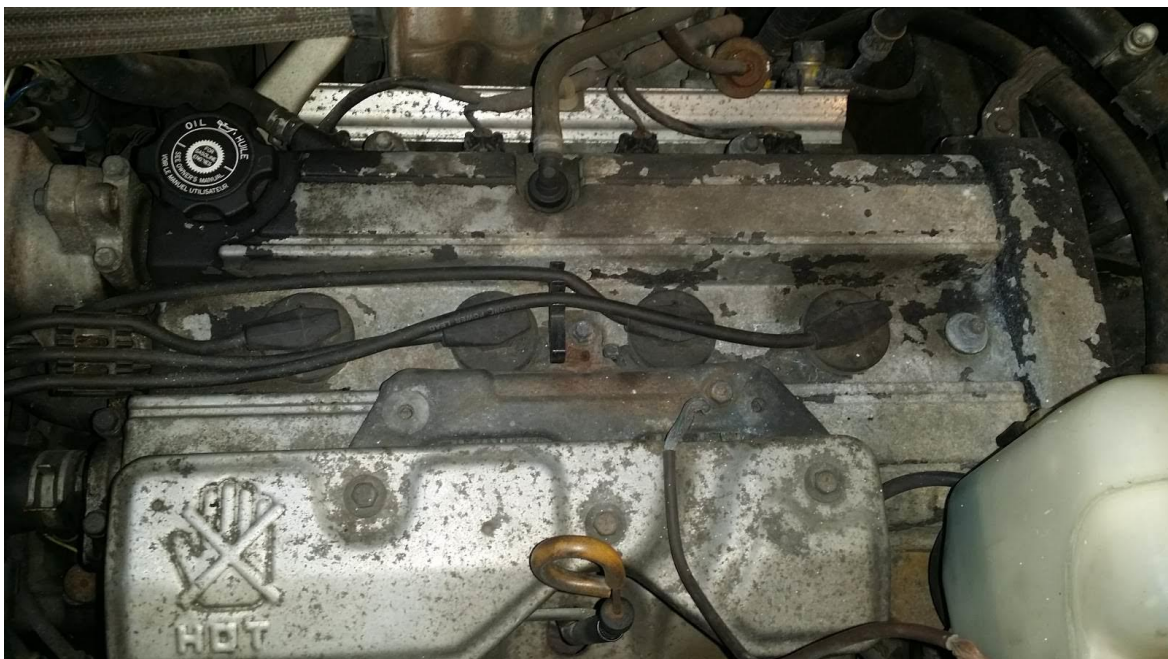
First step is to remove the air box, there are 2 bolts at the front, and 2 at the back. The hoses are just push fit.

Then it should look like this.

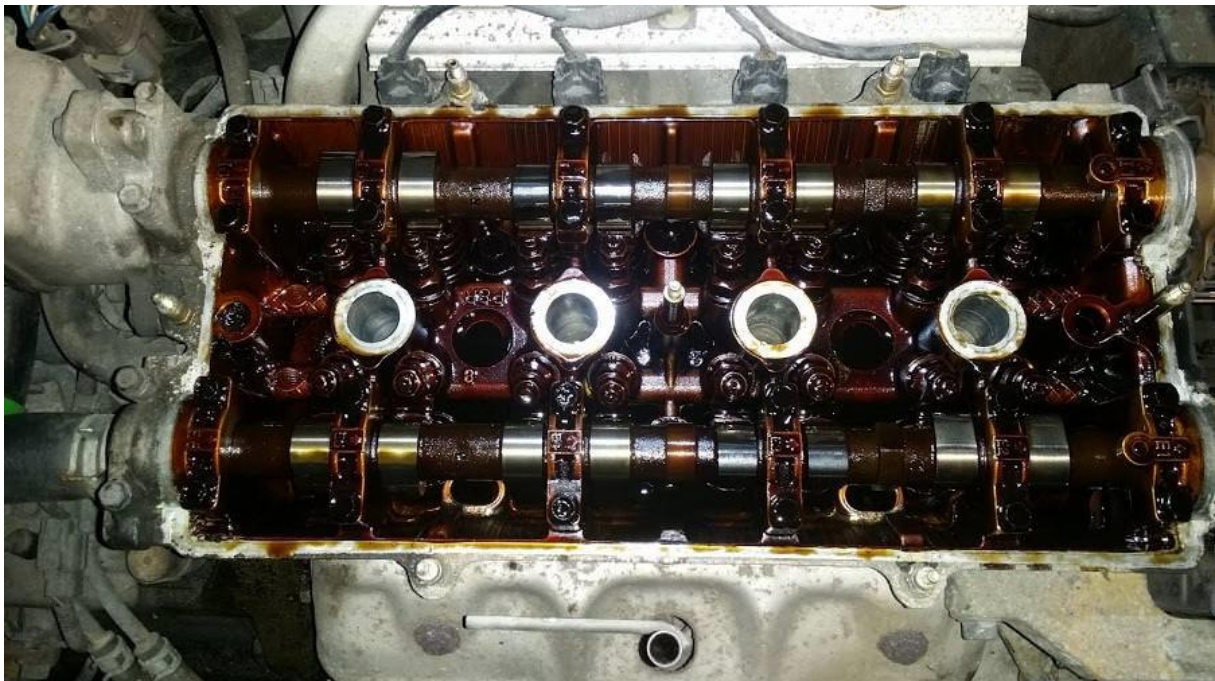
Remove the heat shield, earth strap, remove the 4 spark plug leads (they are different lengths, but feel free to mark them so no not mix them up)

There are then 2 dome nuts at the back, 3 along the middle, 2 at the front.

There is also a bracket at the back right, and 2 breather hoses.

Then pull the cam cover off, do not tip it as you risk losing the nut washers and dropping debris in the engine! Be careful with the cam cover gasket and don't split it!

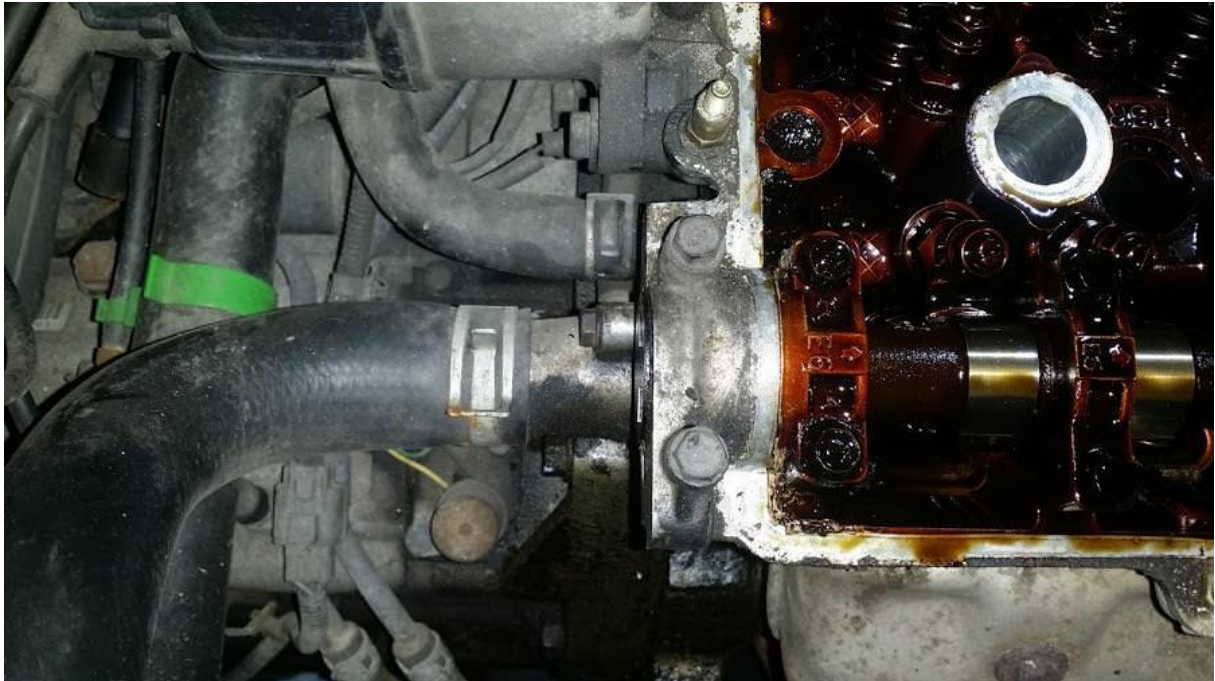
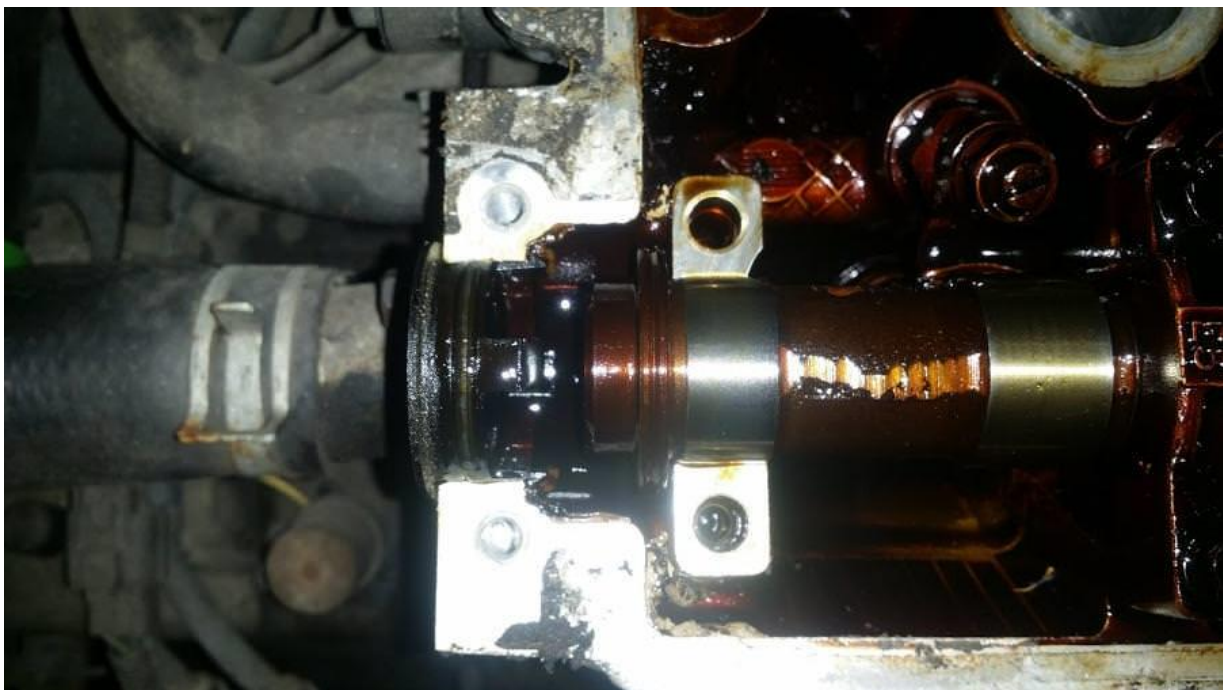
Then remove the bottom left cam clamp here, 4 bolts, careful they are different lengths

You can then access the end seal cap, remove it and clean away the oil. Clean both the head and cam clamp surfaces where the end cap sits.

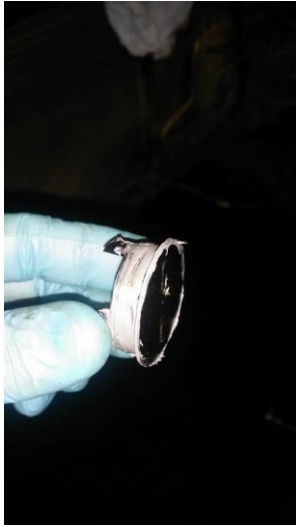
Apply a thin bead of hondabond sealant to the seal.

Refit the cam end seal and cam clamp.

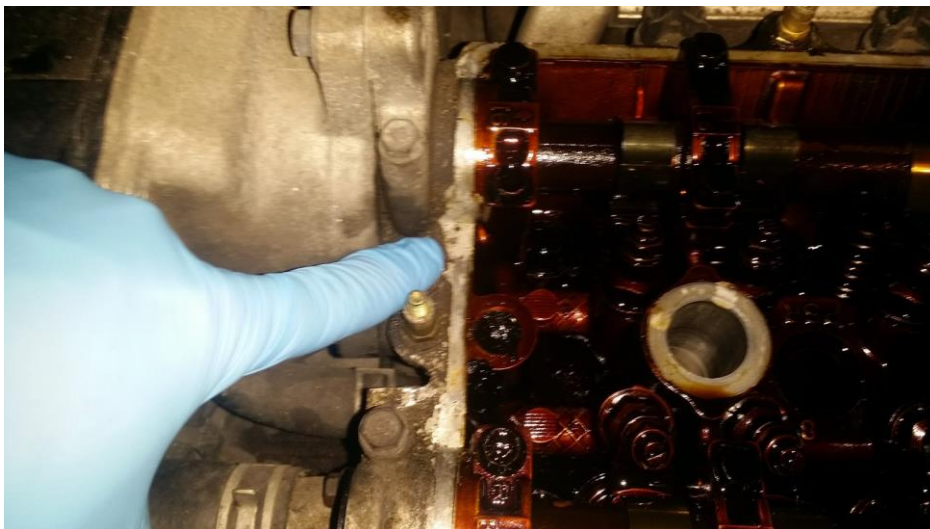
Clean the Head of excess old sealant (usually located on each cam clamp dome)

Fit cam cover gasket and spark plug rings into cam cover.

Apply hondabond sealant to the cam dome corners, and I always recommend a small smear of hondabond along the front edge of the head.

Refit everything and you're done!
